# PHYSICAL NEEDS ASSESSMENT

## SHAKER LANE SCHOOL

**EMG Project #:** 104477.13R-004.017

**Date of Report:** July 15, 2013

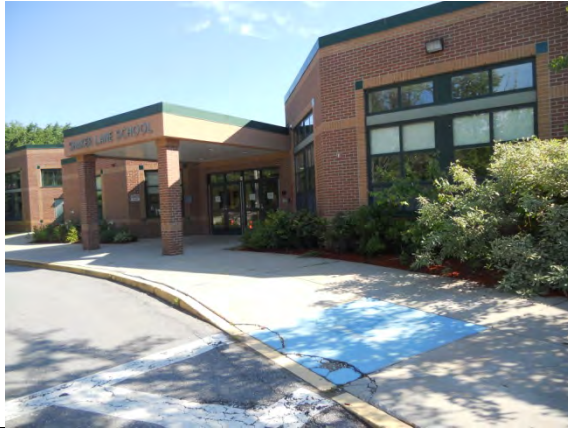
| Photo #1: | Front entrance and deteriorated curb cut |

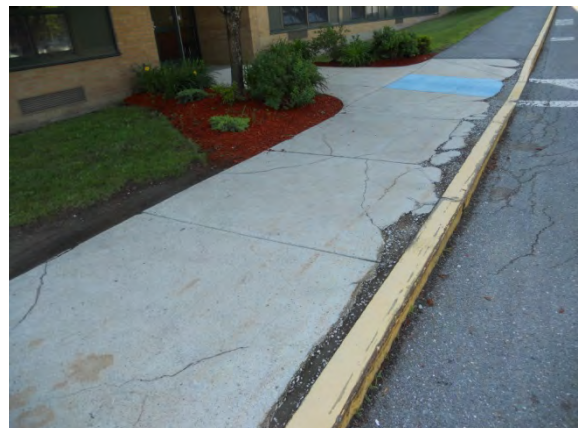
| Photo #12: | Cracked and deteriorated sidewalk along west side of building |

| Report Section | ID | Cost Description | Lifespan (EUL) | E | Age | RUL | Quantity | Unit | Unit Cost | Subtotal | 2013 | 2014 | 2015 | 2016 | 2017 | 2018 | 2019 | 2020 | 2021 | 2022 | 2023 | 2024 | 2025 | 2026 | 2027 | 2028 | 2029 | 2030 | 2031 | 2032 | Deficiency Repair Estimate |
|---|---|---|---|---|---|---|---|---|---|---|---|---|---|---|---|---|---|---|---|---|---|---|---|---|---|---|---|---|---|---|---|
| 5.2 | 209287 | G2031 Remove & replace concrete sidewalk | 25 | 25 | 0 | 1152 | | SF | \$8.96 | \$10,322 | \$10,322 | | | | | | | | | | | | | | | | | | | | \$10,322 |

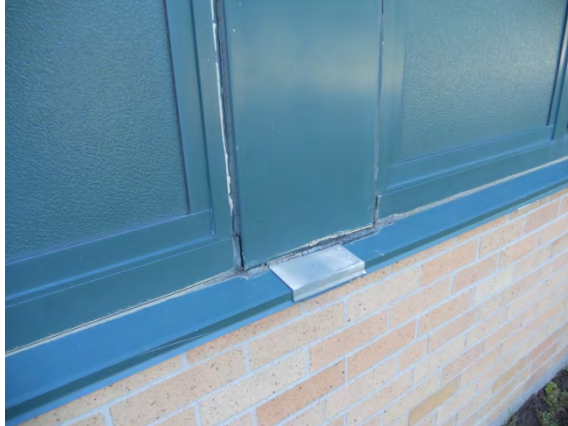
Photo #13: Deteriorated sealant at spandrel panels

| Report Section | ID | Cost Description | Lifespan (EUL) | E | Age | RUL | Quantity | Unit | Unit Cost | Subtotal | 2013 | 2014 | 2015 | 2016 | 2017 | 2018 | 2019 | 2020 | 2021 | 2022 | 2023 | 2024 | 2025 | 2026 | 2027 | 2028 | 2029 | 2030 | 2031 | 2032 | Deficiency Repair Estimate |
|---|---|---|---|---|---|---|---|---|---|---|---|---|---|---|---|---|---|---|---|---|---|---|---|---|---|---|---|---|---|---|---|
| 6.4 | 209402 | B2011 Caulking, polyurethane,1/4"x1/4", remove and replace | 15 | 14 | 1 | 1600 | | LF | \$3.84 | \$6,144 | | \$6,144 | | | | | | | | | | | | | | | \$6,144 | | | | \$12,288 |

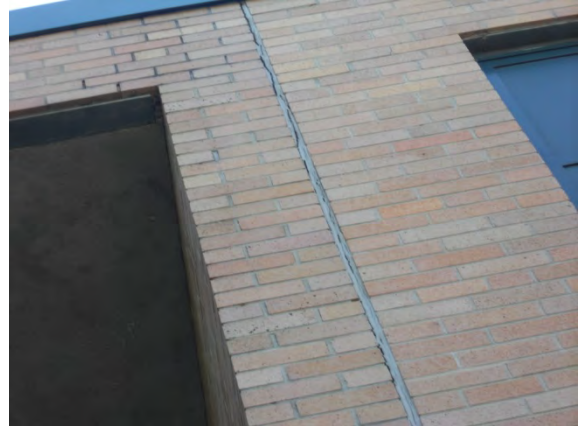
Photo #14: Deteriorated expansion joint

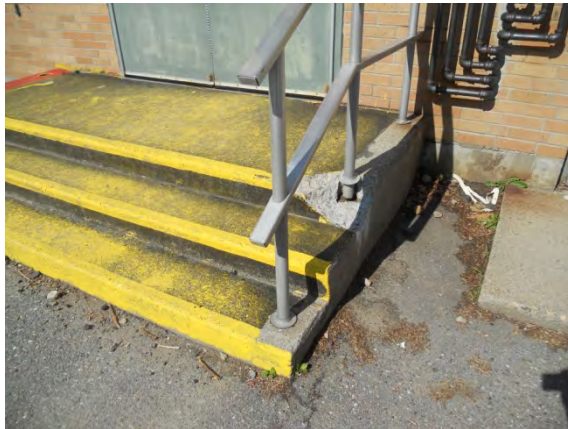
Photo #15: Deteriorated concrete at rear steps

| Report Section | ID | Cost Description | Lifespan (EUL) | E | Age | RUL | Quantity | Unit | Unit Cost | Subtotal | 2013 | 2014 | 2015 | 2016 | 2017 | 2018 | 2019 | 2020 | 2021 | 2022 | 2023 | 2024 | 2025 | 2026 | 2027 | 2028 | 2029 | 2030 | 2031 | 2032 | Deficiency Repair Estimate |
|---|---|---|---|---|---|---|---|---|---|---|---|---|---|---|---|---|---|---|---|---|---|---|---|---|---|---|---|---|---|---|---|
| 6.5 | 209417 | G2035 Cast-in-place concrete stair repair | 0 | 0 | 0 | 75 | | LF Nosing | \$6.75 | \$506 | \$506 | | | | | | | | | | | | | | | | | | | | \$506 |

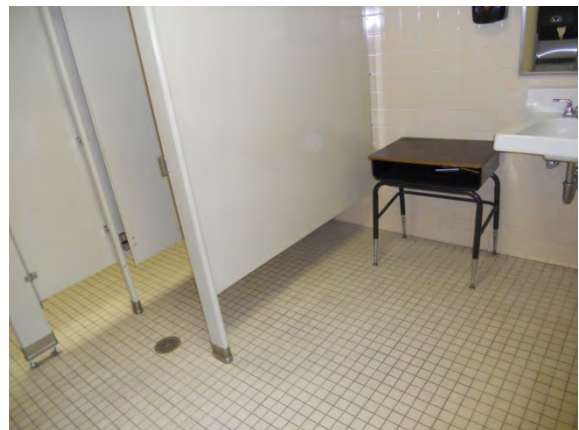
Photo #18: Common area restroom with no drain pipe insulation

| Report Section | ID | Cost Description | Lifespan (EUL) | E | Age | RUL | Quantity | Unit | Unit Cost | Subtotal | 2013 | 2014 | 2015 | 2016 | 2017 | 2018 | 2019 | 2020 | 2021 | 2022 | 2023 | 2024 | 2025 | 2026 | 2027 | 2028 | 2029 | 2030 | 2031 | 2032 | Deficiency Repair Estimate |
|---|---|---|---|---|---|---|---|---|---|---|---|---|---|---|---|---|---|---|---|---|---|---|---|---|---|---|---|---|---|---|---|
| 3.2 | 209273 | C1031 ADA, Wrap drain pipes below accessible lavatory | 0 | 0 | 0 | 3 | | EA | \$65.00 | \$195 | \$195 | | | | | | | | | | | | | | | | | | | | \$195 |

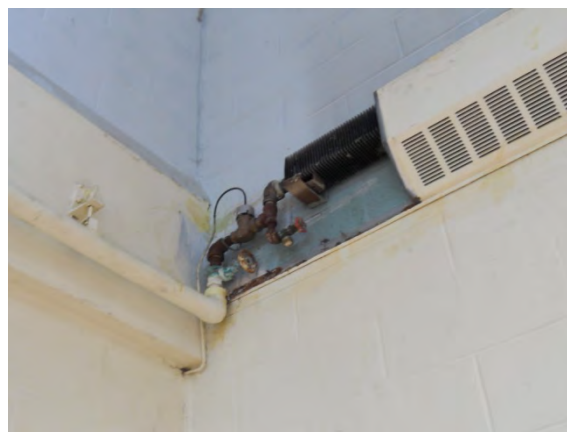
Photo #24: Wall mounted radiant heater with missing cover

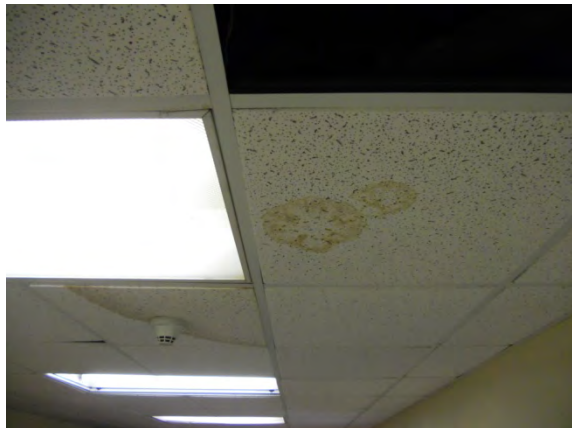
EMG observed the presence of water damaged ceiling tiles, in the areas cited below:

Photo #25: Water staining

EMG recommends replacing the affected ceiling tiles and routinely clean and clear roof drains. Monitoring is also recommended for any active leaks as none were observed.

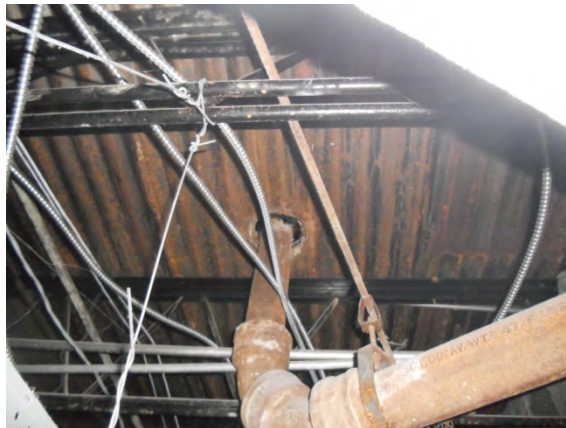
Photo #26: Drain line above stained ceiling tiles

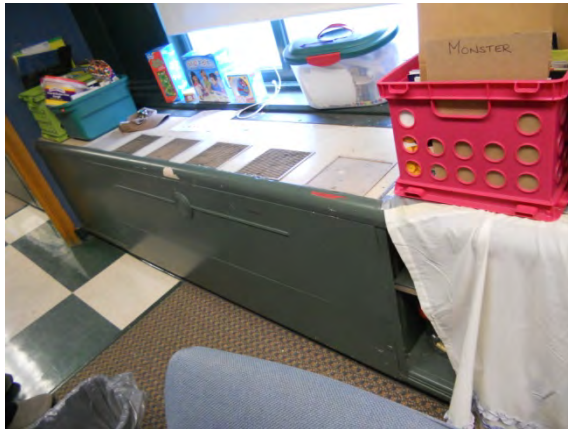
Photo #33: Older univentilator

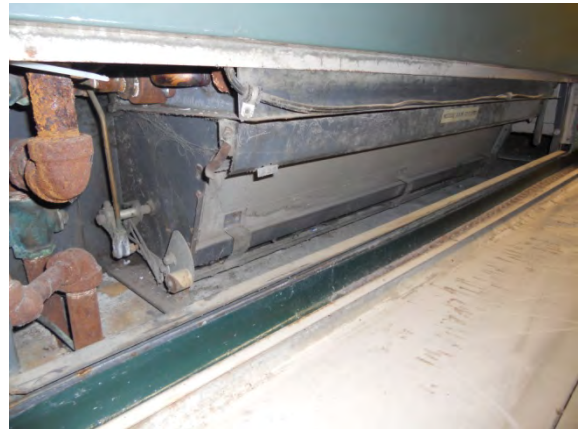
Photo #34: Older univentilator piping and grill

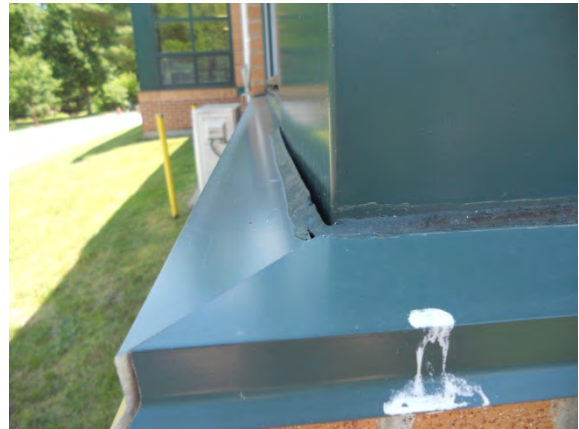
Photo #40: Deteriorated sealant at rear of building at kindergarten classroom addition

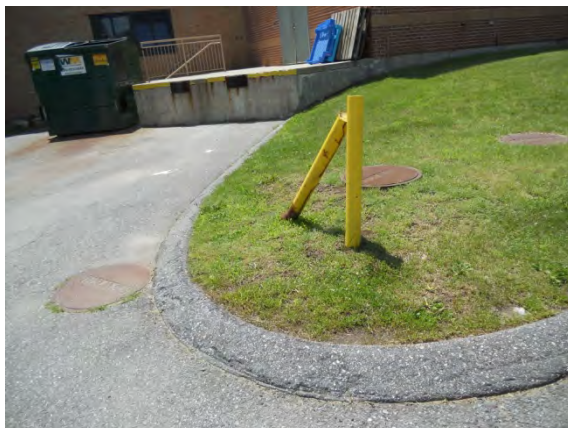
Photo #41: Loading dock with damaged bollards

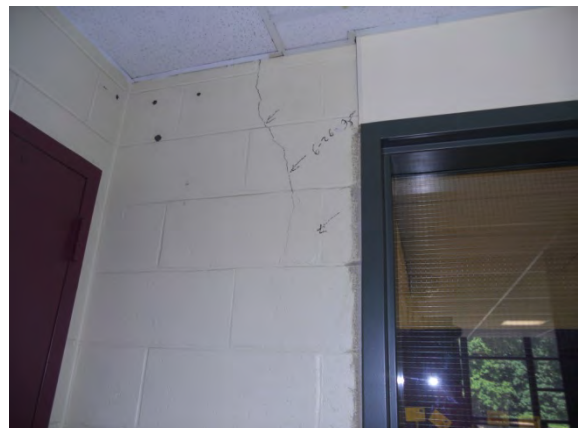
Photo #42: Settlement cracking at second floor of stairwell adjacent to generator room

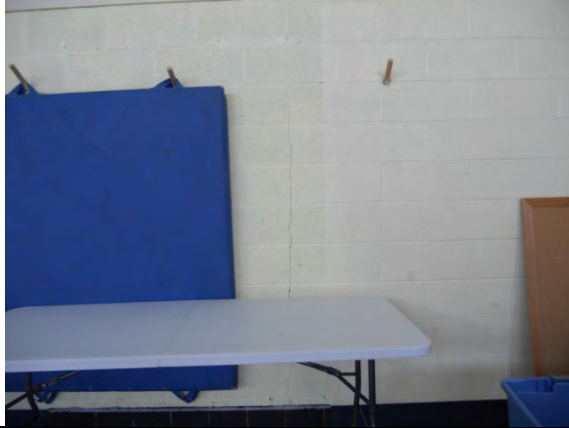
Photo #43: Cracking in gymnasium

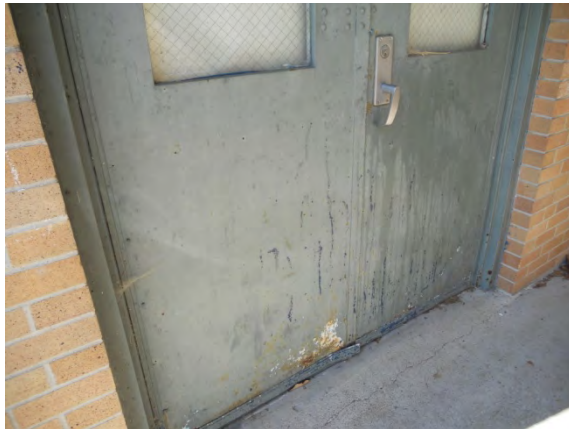
Photo #51: Rusted and deteriorated service door

| Report Section | ID | Cost Description | Lifespan (EUL) | E | Age | RUL | Quantity | Unit | Unit Cost | Subtotal | 2013 | 2014 | 2015 | 2016 | 2017 | 2018 | 2019 | 2020 | 2021 | 2022 | 2023 | 2024 | 2025 | 2026 | 2027 | 2028 | 2029 | 2030 | 2031 | 2032 | Deficiency Repair Estimate |
|---|---|---|---|---|---|---|---|---|---|---|---|---|---|---|---|---|---|---|---|---|---|---|---|---|---|---|---|---|---|---|---|
| 6.6 | 209433 | B2031A Replace 6'-0" x 7'-0" steel double door with frame and hardware | 35 | 34 | 1 | 1 | | EA | \$2,573.50 | \$2,574 | | \$2,574 | | | | | | | | | | | | | | | | | | | \$2,574 |
