# Littleton Town Hall Building & Space Needs Assessment

## Volume I: Executive Summary

Littleton Town Hall Complex  
37 Shattuck Street  
Littleton, MA 01609

March 5, 2021

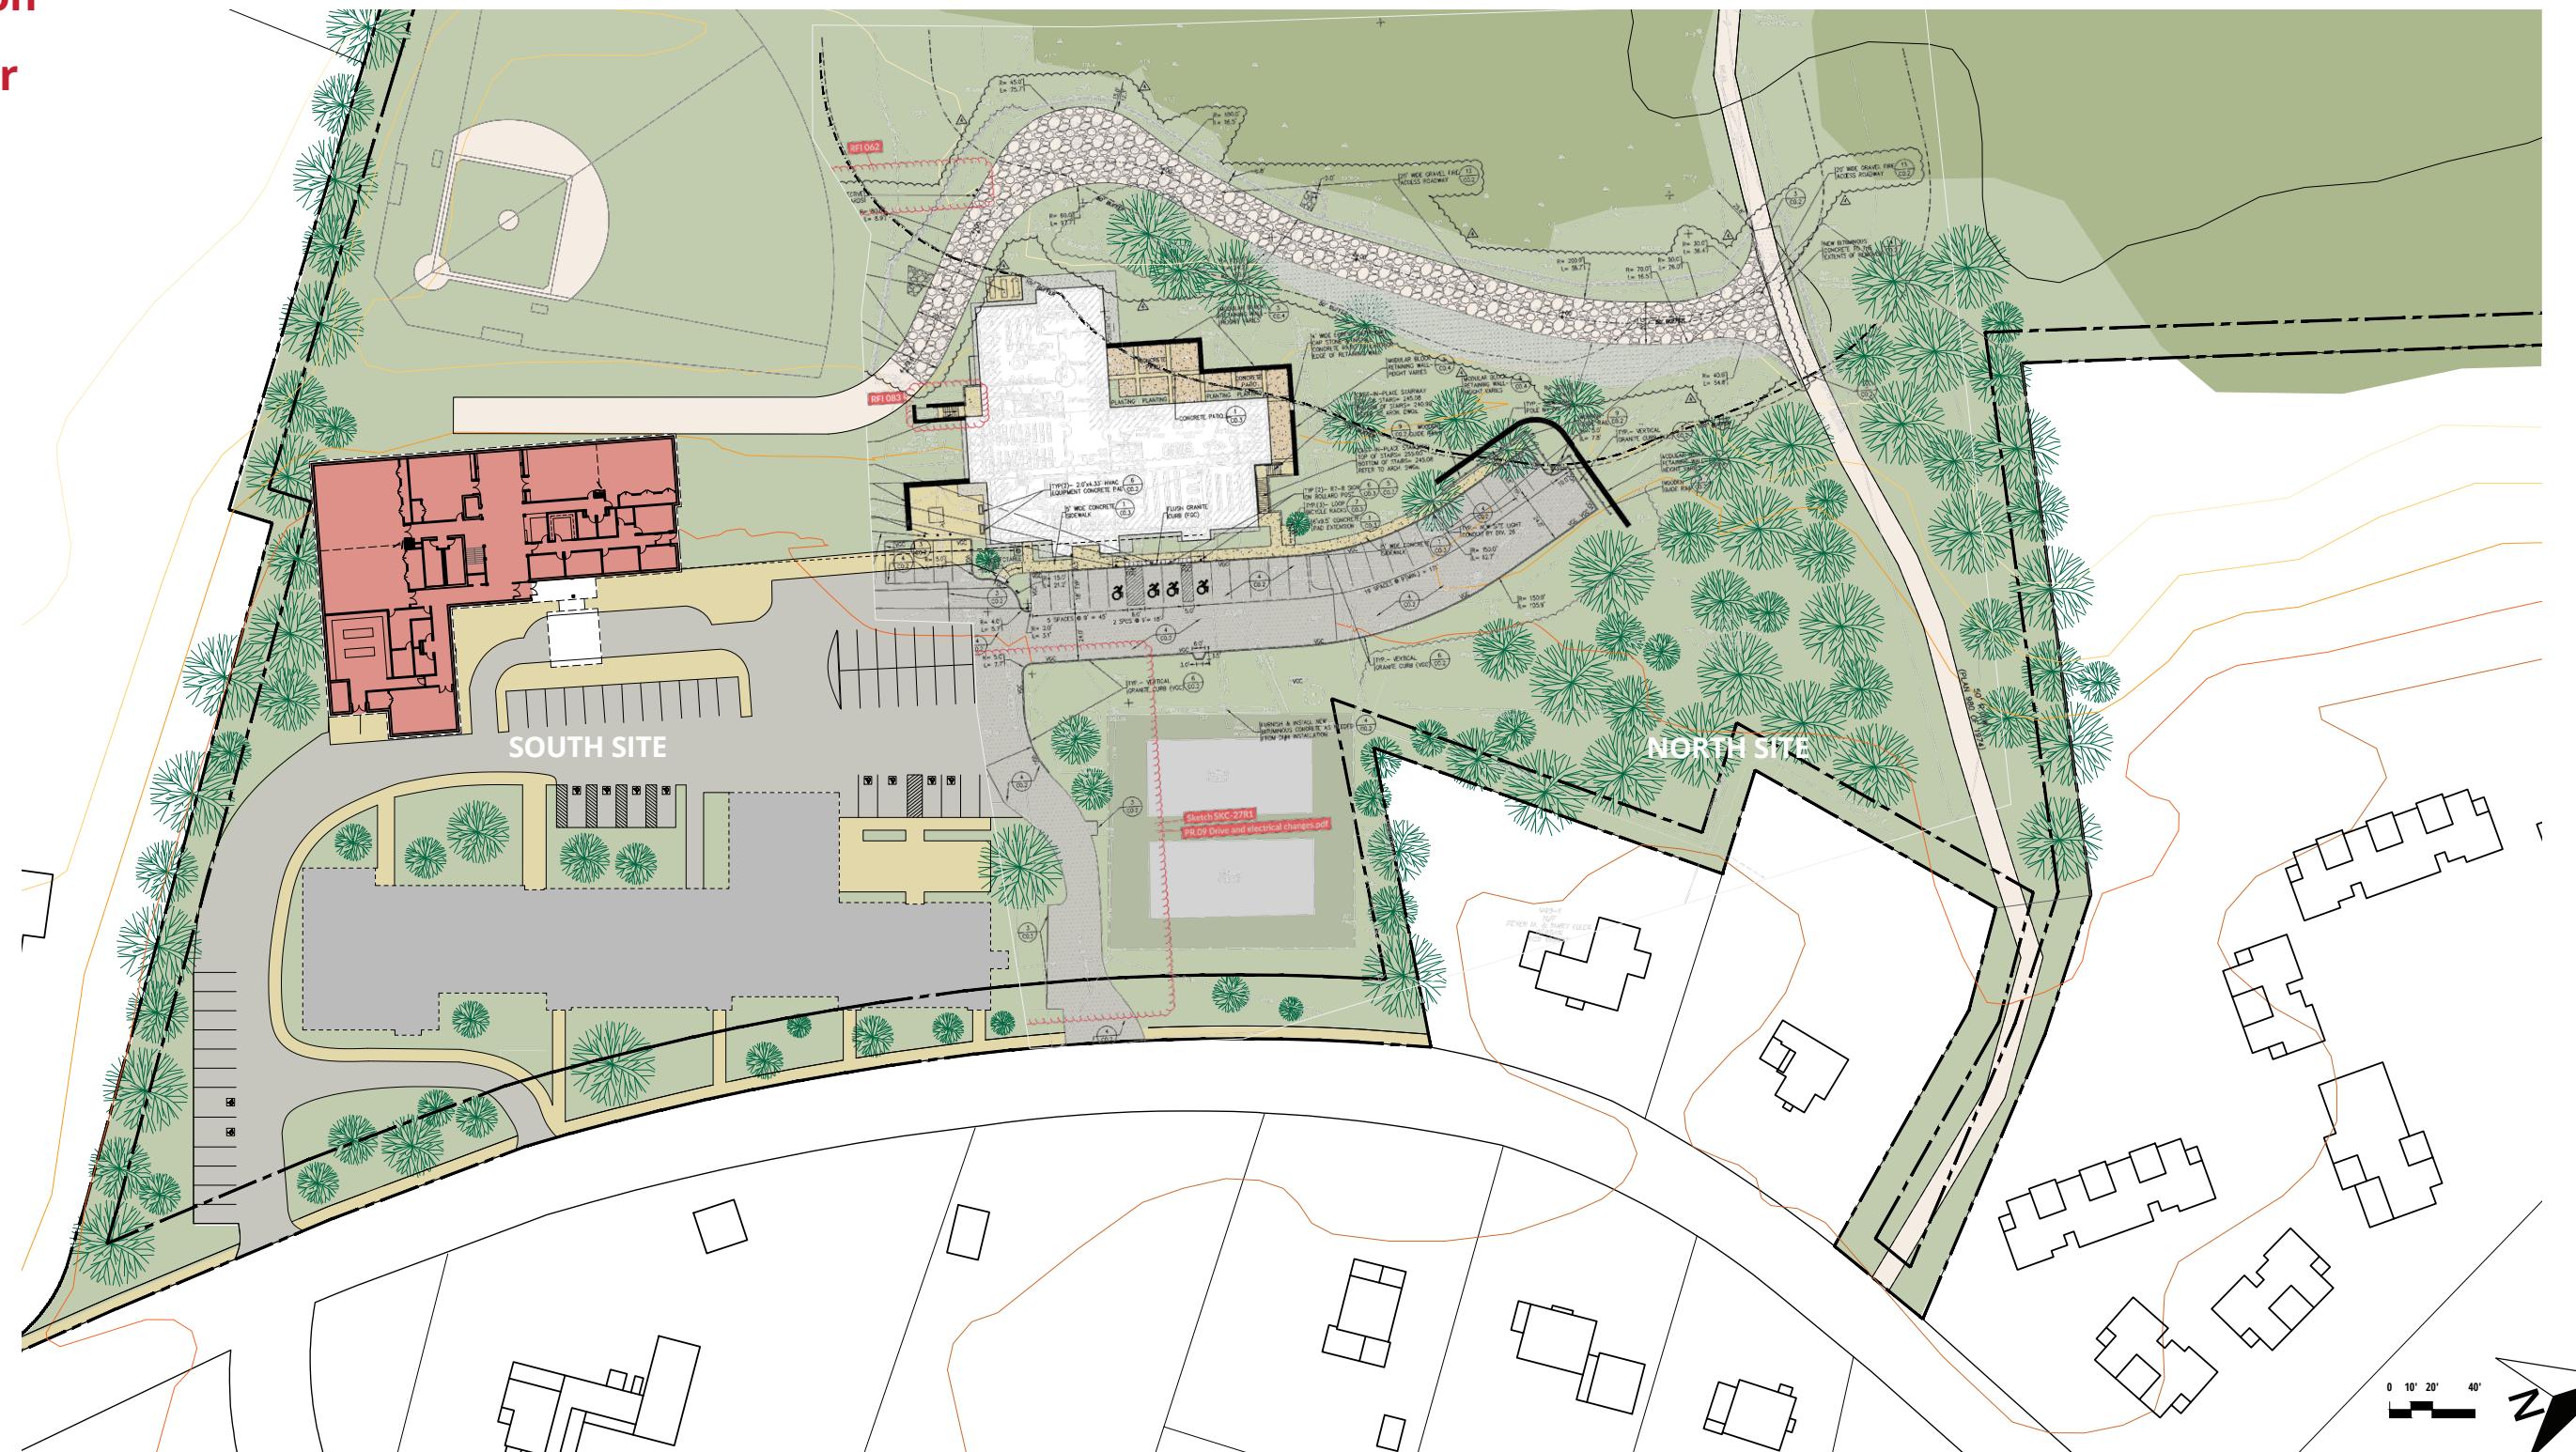
### Proposed Littleton EHS / COA Center Site Plan

The proposed new EHS building plan locates the entrance on the parking lot side, in line with that for the library. A porch-like front entry is proposed to welcome visitors. A portico is recommended for convenient vehicular drop-off in all weather. A receptionist would be centrally located to oversee the entrance and a large lobby serving as both a common room and waiting area. Offices would be conveniently located close to parking. EHS Program rooms, designed for flexible use, are proposed on the northwest side of the building to take advantage of the valley view.

The kitchen, delivery and back of house areas are proposed to be on the southeast/parking lot side, to facilitate access for large vehicles and to keep these functions from crossing the paths of patrons. A large, dividable multipurpose space is proposed for dining, program and event use. This space would have northwest and southwest windows and access to grade on the southwest side. This outdoor area might be used for small outdoor programs or patio seating.

The proposed plan is "L" shaped with the long leg parallel with the hill to mitigate the change in grade. The shorter bar extends in to the parking lot to maximize the southern exposure of the multi-purpose space and allow for on-grade egress from that assembly area.

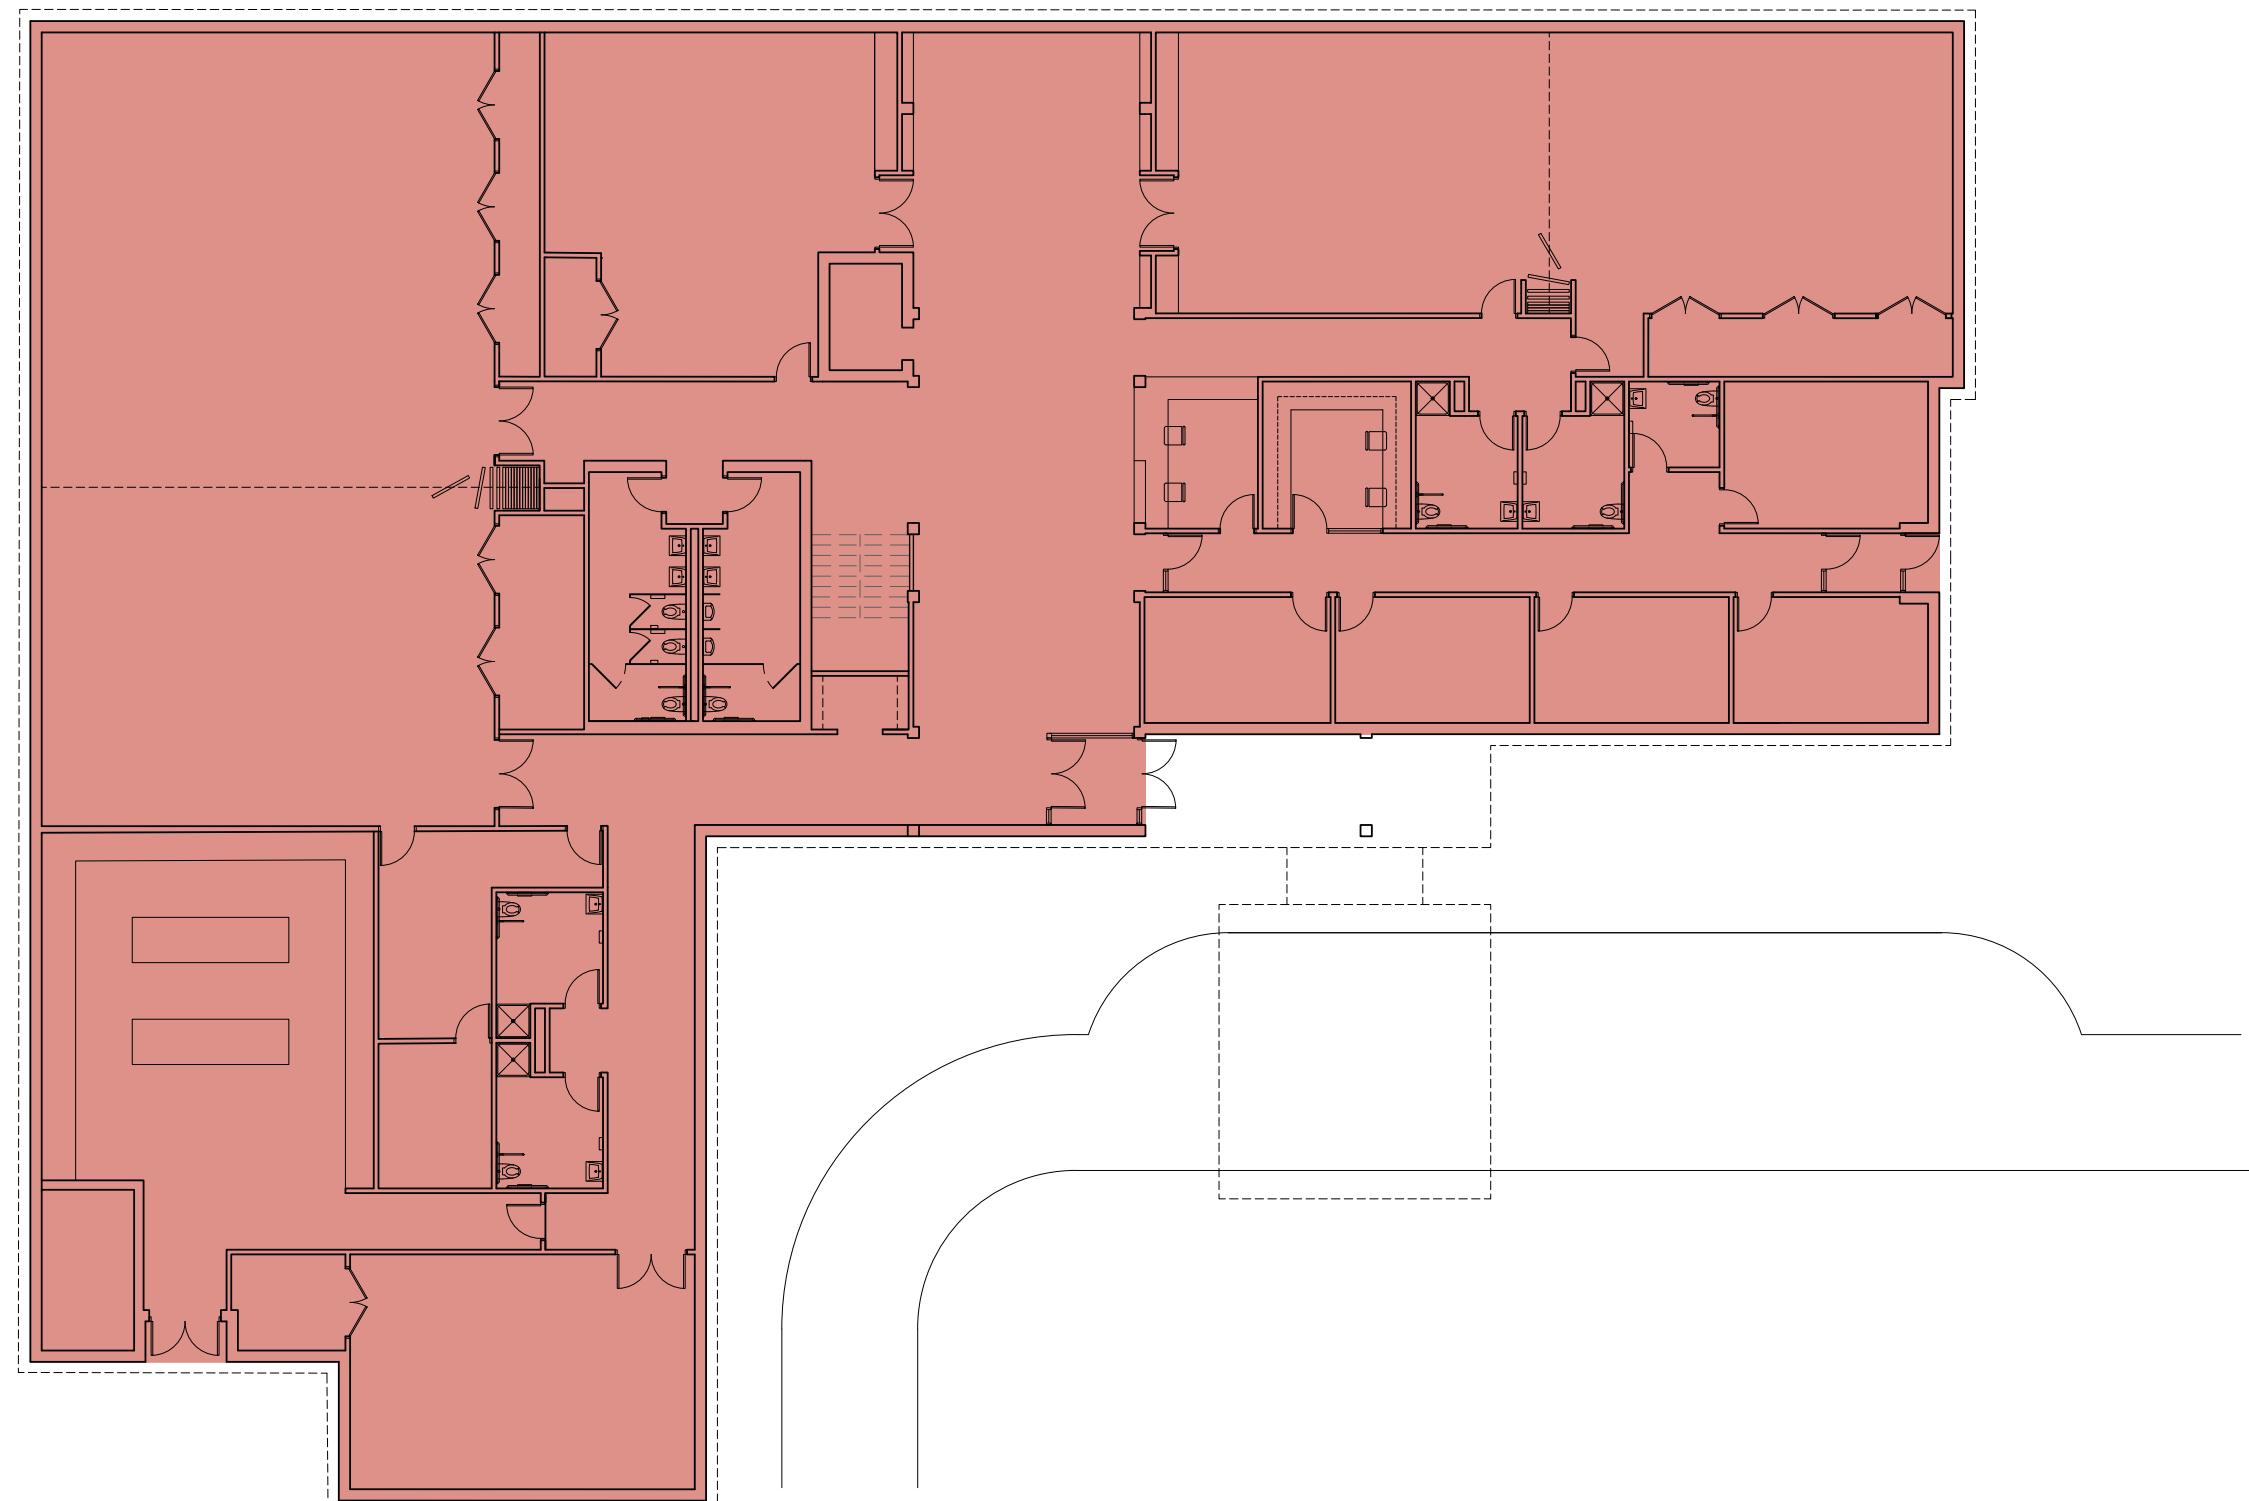
**Proposed Littleton  
EHS / COA Center  
Floor Plan**

*First Floor*

At this point in time the current concept plan proposes that the entire program be located on a single level to facilitate oversight, minimize staffing, and simplify accessibility, as requested by the Needs Assessment Project Committee. The new structure is proposed to be located within the property setbacks to the southwest of the new library and sited on the hill in a similar fashion. The two structures would be linked by a connecting sidewalk.

The change of grade is expected to result in the need for a full height, lower level with the potential to walk out on grade. Further consideration of the use and costs associated with the lower level is recommended. It may prove to make sense to locate program space for EHS or another department here, to justify this expense.

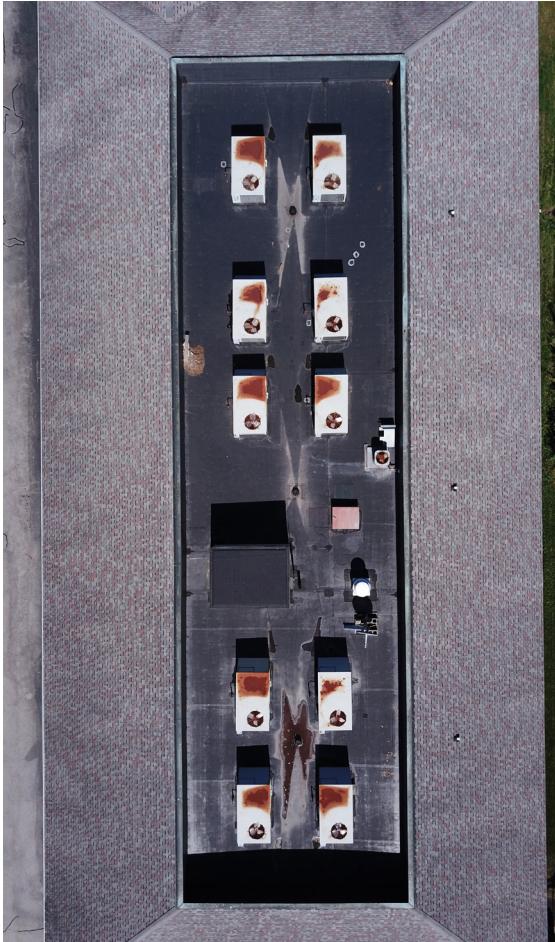
Evidence of deteriorated RTUs in need of replacement.

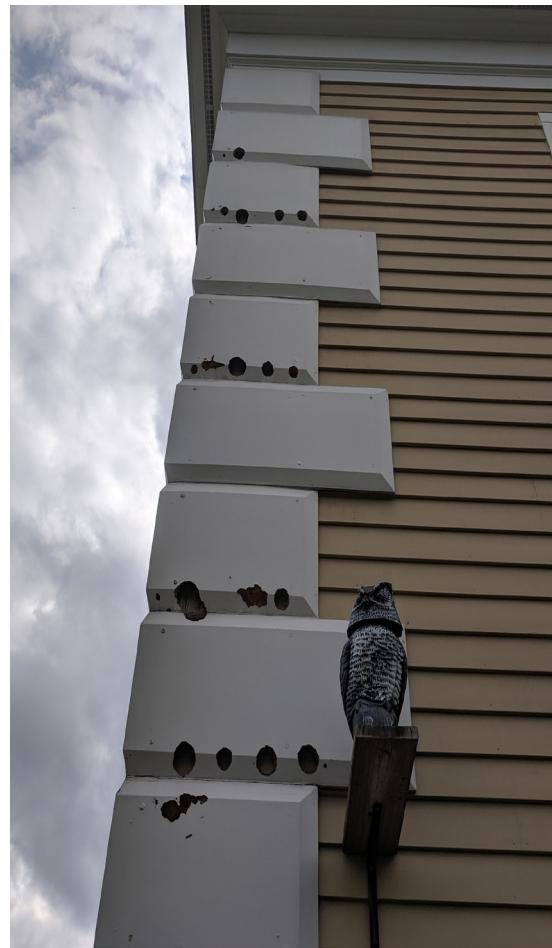
Closeup at damaged painted foam quions from woodpeckers at northeast corner.

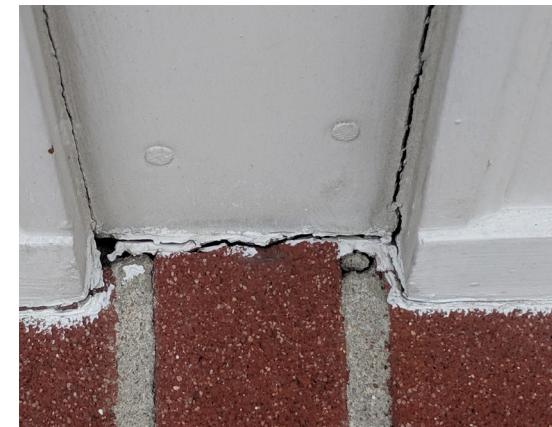
Evidence of missing mortar and lack of sealant, this is a source of potential water infiltration.

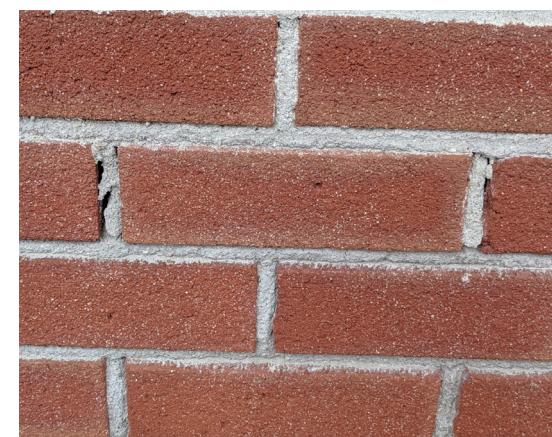
Poorly toothed mortar, separation can be seen at head joint.

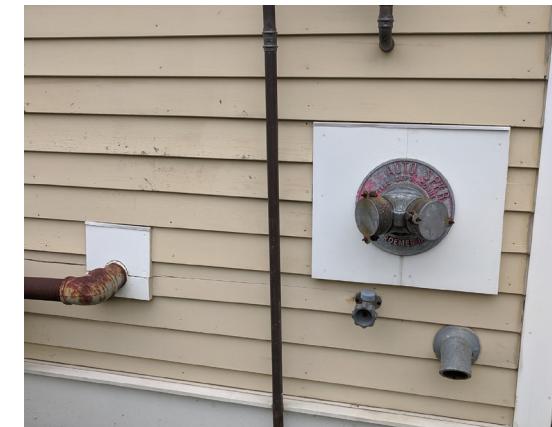
Visible horizontal crack in clapboard siding and trim at pipe penetration.

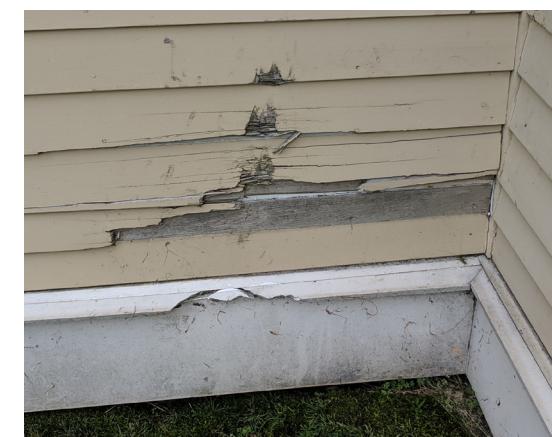
Evidence of missing and damaged clapboard sections, and wood trim.

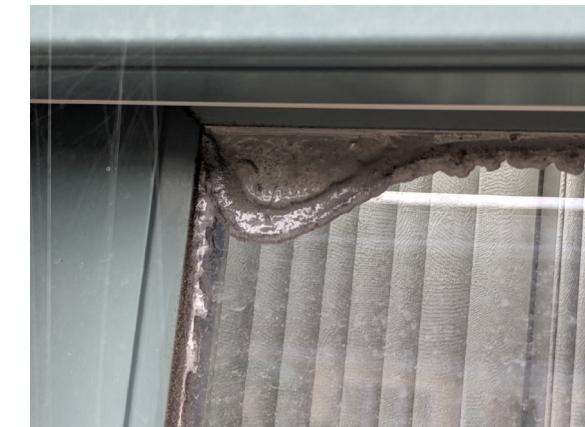
Evidence of sealant failure at sash head.

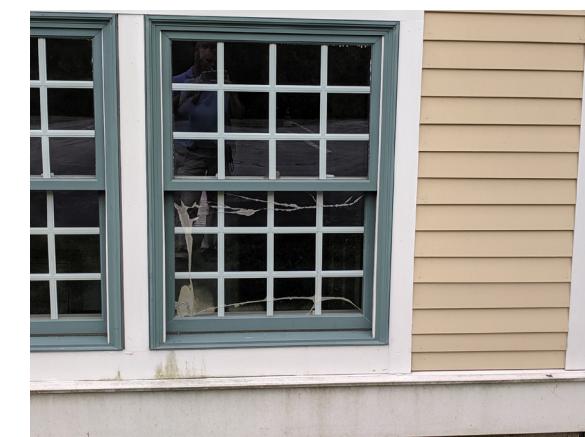
IGU at lower sash broken, should be replaced.

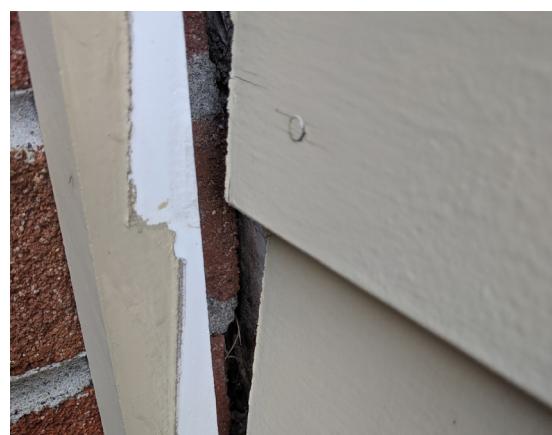
Closeup at vertical trim board separation, exposing wall back up. We can note that there is no evidence of a sealant joint.

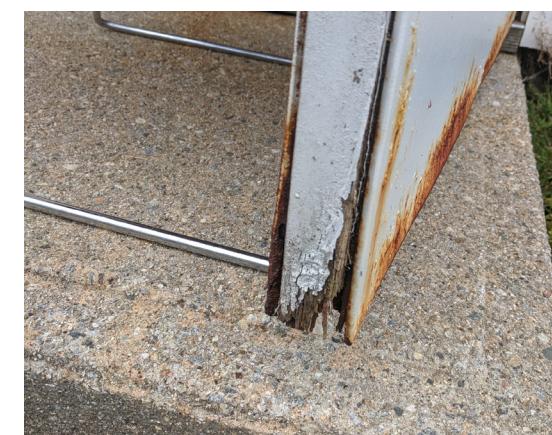
Evidence of damaged & deteriorated paint finish, and rotting (loss) of core material.

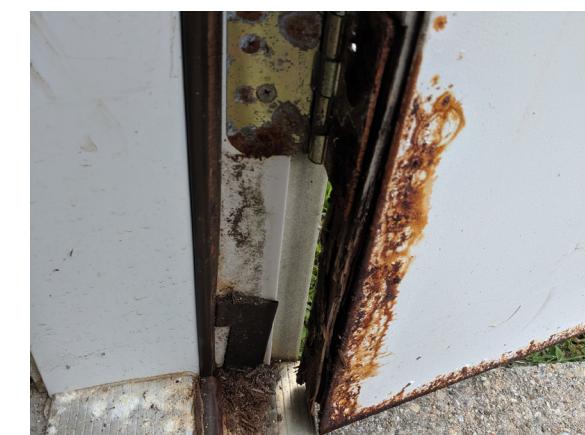
Evidence of damaged & deteriorated paint finish, and rotting core material.

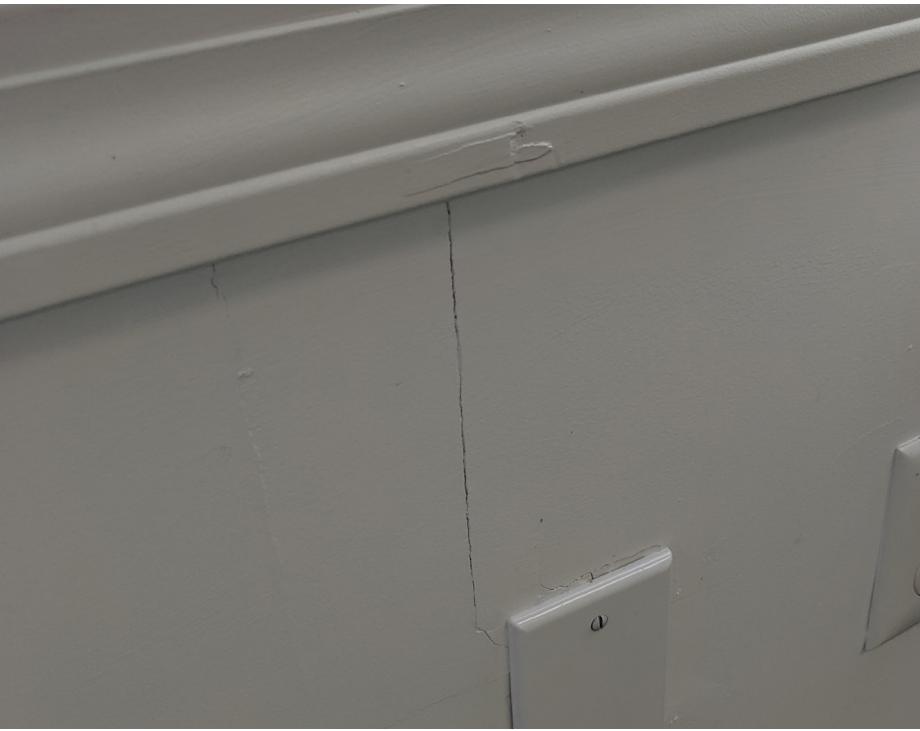
Observed crack at exterior wall below window, first floor east.

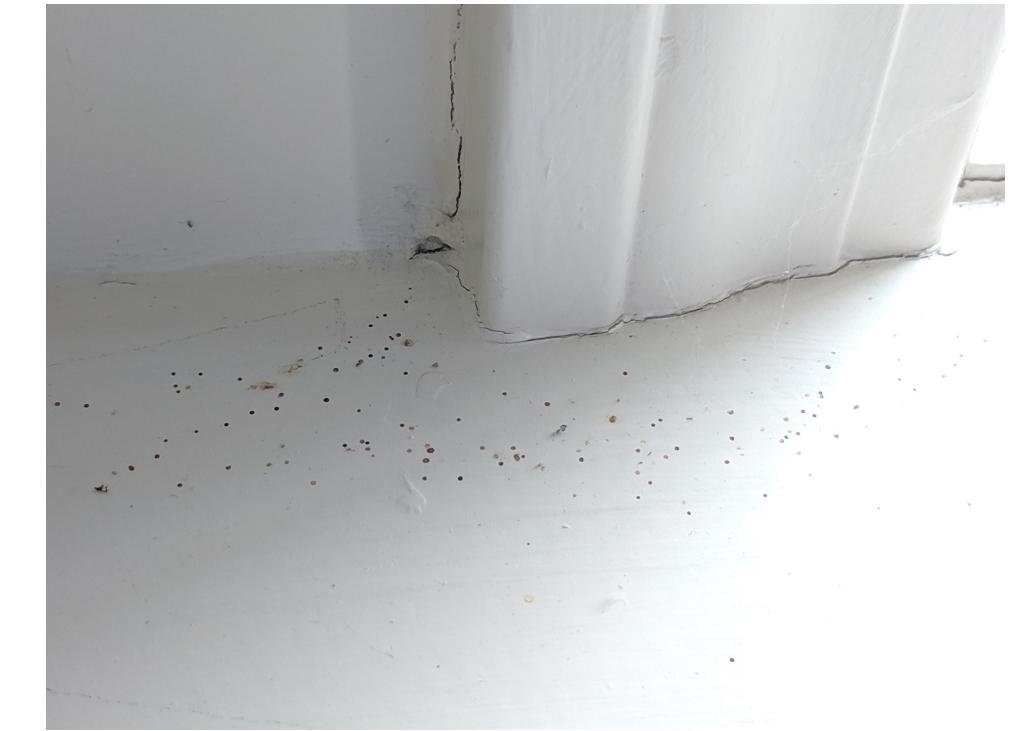
Visible evidence of pest activity at East window sill, first floor.

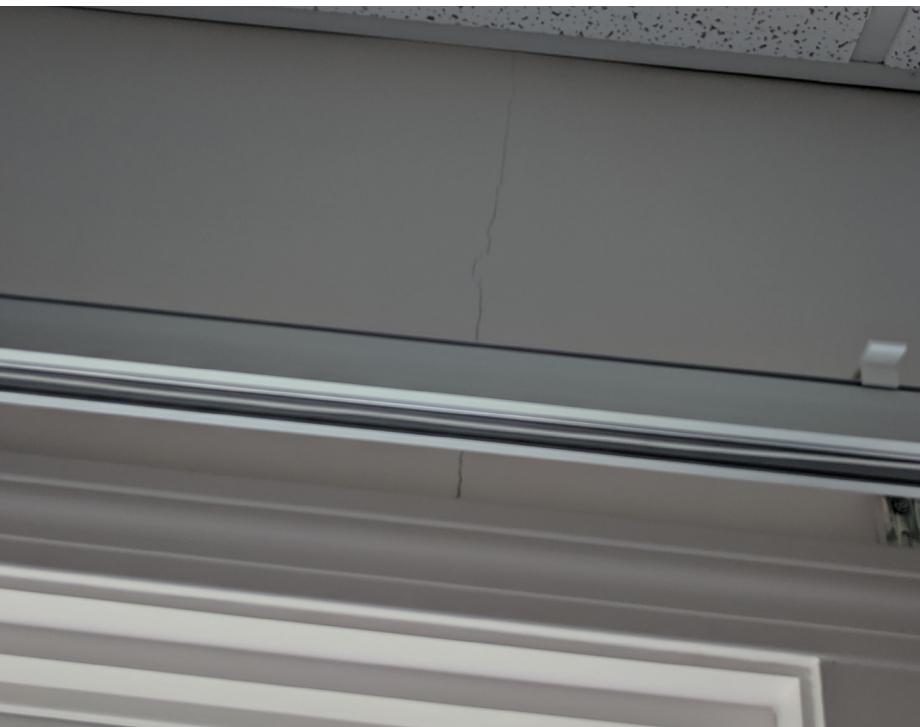
Observed crack above window head, second floor east wall.

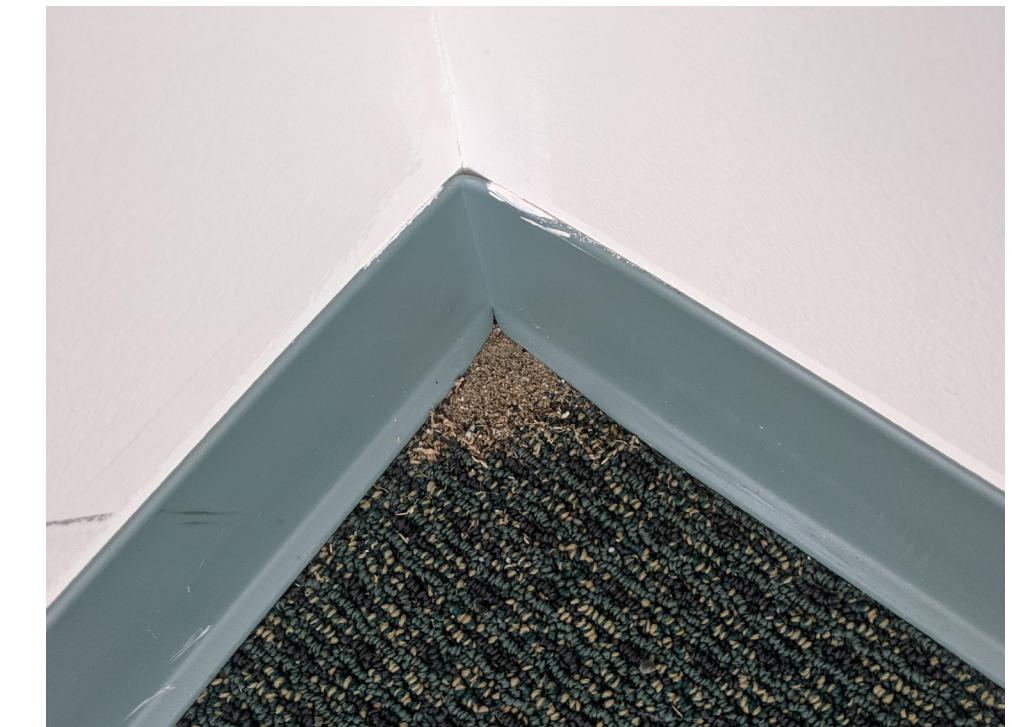
Evidence of what appears to be frass, first floor East corner at wall base corner.

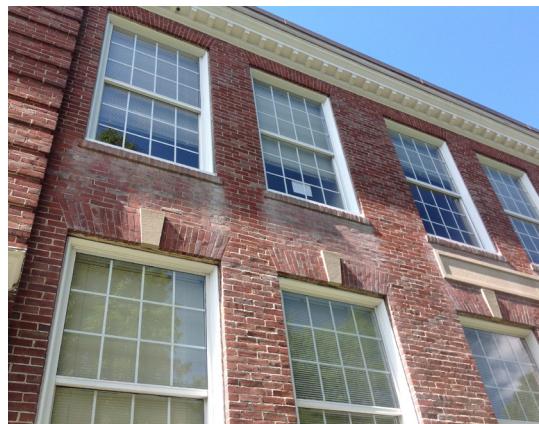
Evidence of staining/soiling at window sills. (Office Wing - Shattuck Street Side)

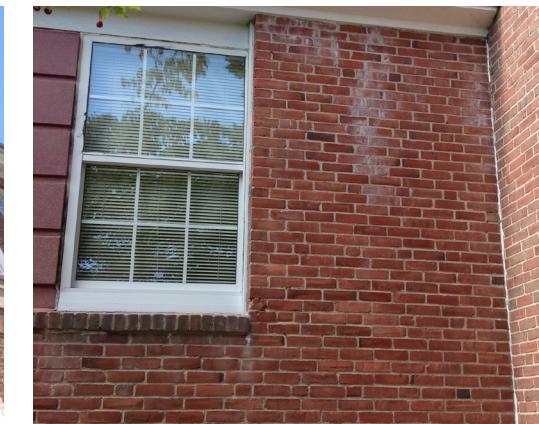
Evidence of efflorescence near window opening. (Library Wing - Shattuck Street Side)

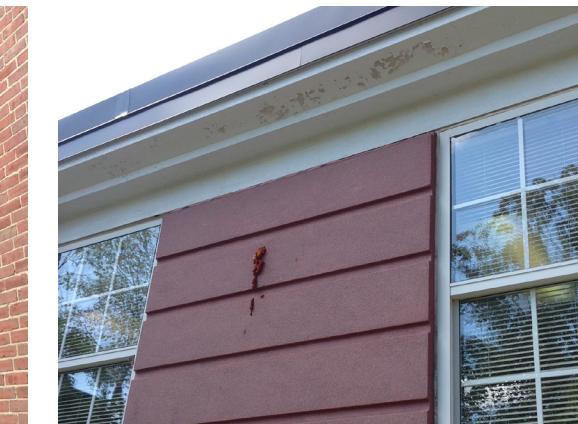
Damage from nesting birds that has been reactively filled with spray foam that does not match finish of Dryvit. (Library Wing - Shattuck Street Side)

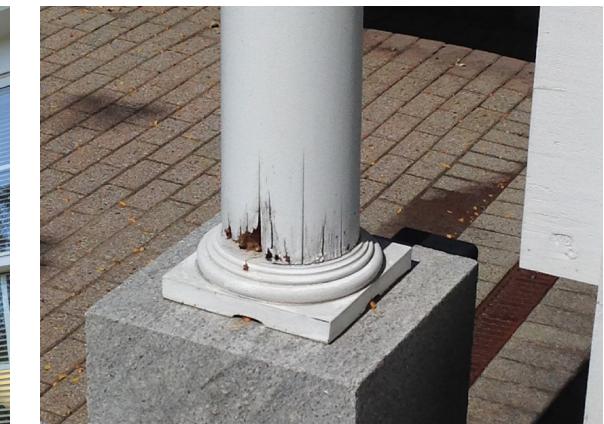
Evidence of cracking/missing wood on column trim. (Library Wing - Parking Lot Side)

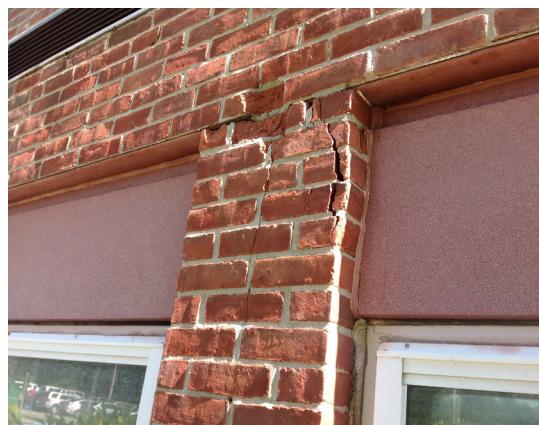
Evidence of brick spalling, most likely from uneven compression and/or water damage. (Library Wing - Parking Lot Side)

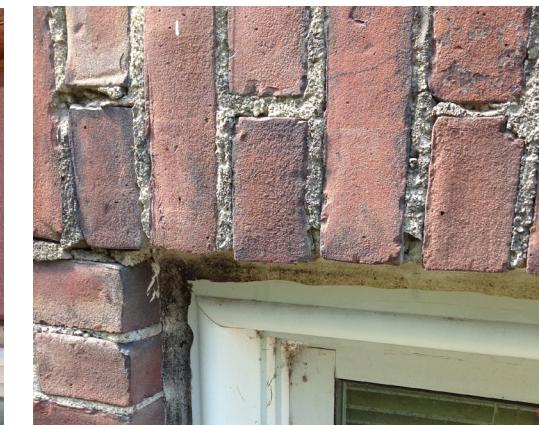
Evidence of eroded mortar joint near window opening. (Office Wing - Shattuck Street Side)

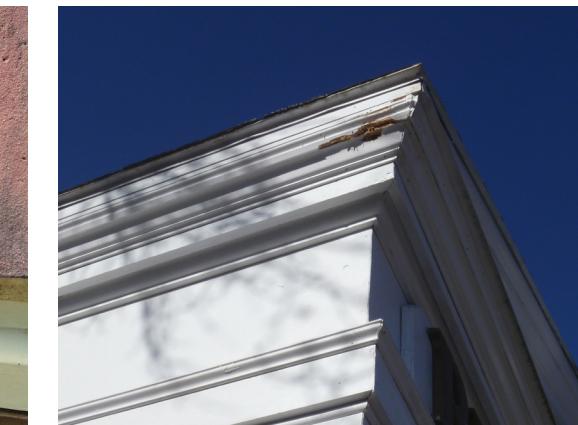
Evidence of damage to trim, most likely from an animal. (Library Wing - Shattuck Street Side)

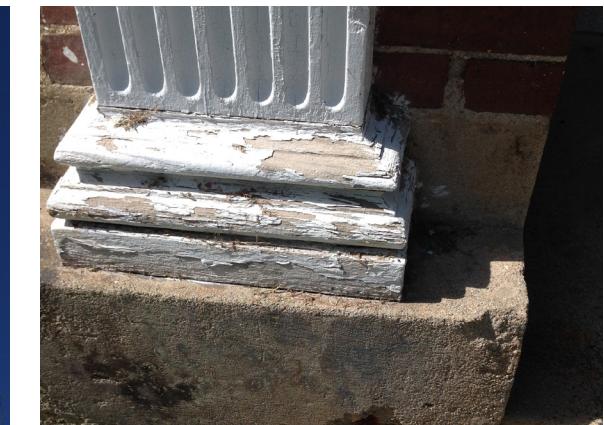
Observed peeled paint on trim board. (Library Wing - Shattuck Street Side)

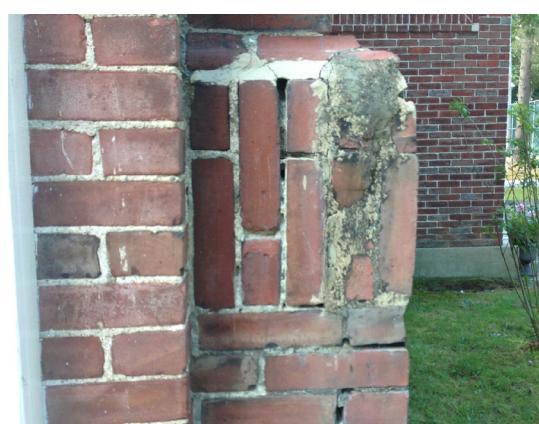
Evidence of attempted patch of corner with mortar and areas of missing mortar. (Office Wing - Shattuck Street Side)

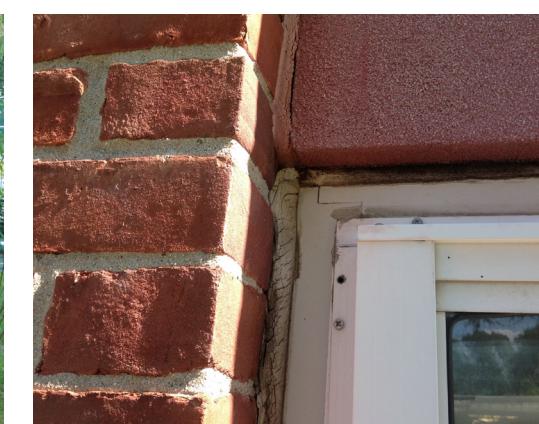
Evidence of cracked caulking at window opening. (Library Wing - Parking Lot Side)

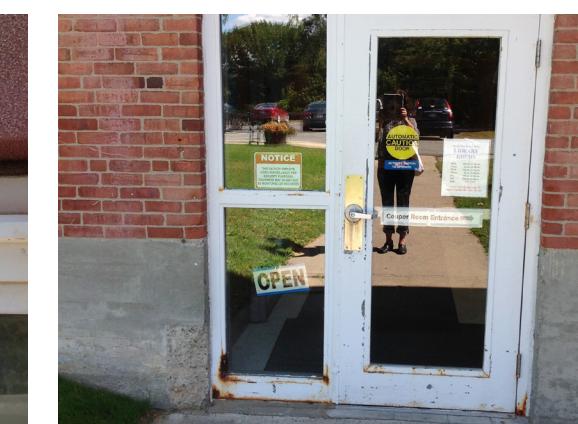
Evidence of damaged & deteriorated paint finish, and rotting (loss) of core material. (Library Wing - Parking Lot Side)

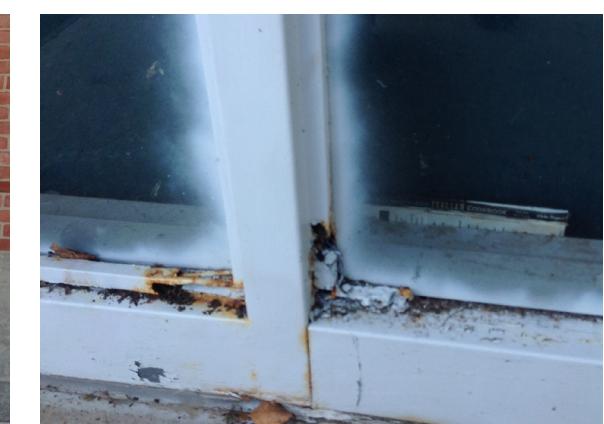
Closeup at of aluminum sidelight sill at library main entrance. (Library Wing - Shattuck Street Side)

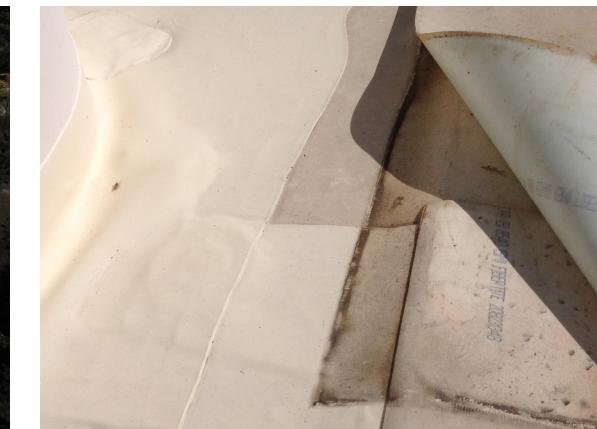
Separation of an already repaired joint (via applied darker coating) occurring in mansard wall. (Classroom Wing - Roof 5)

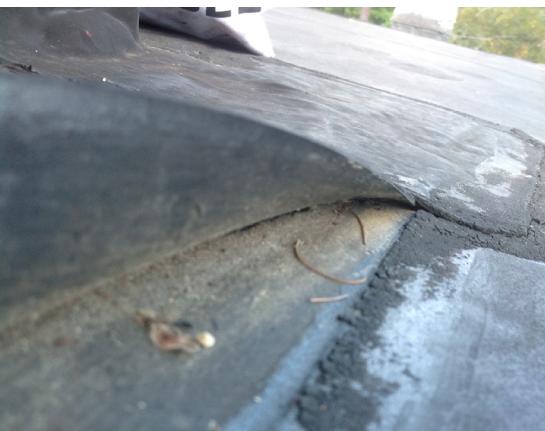
Evidence of water ponding, signs of aged flashings can be seen where membranes separate, or "pull back". (Multi-Use Wing - Roof 6)

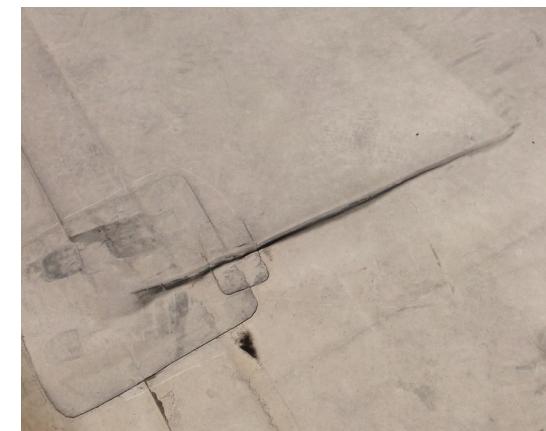
Wrinkled membrane poses a tripping hazard. (Classroom Wing - Roof 5)

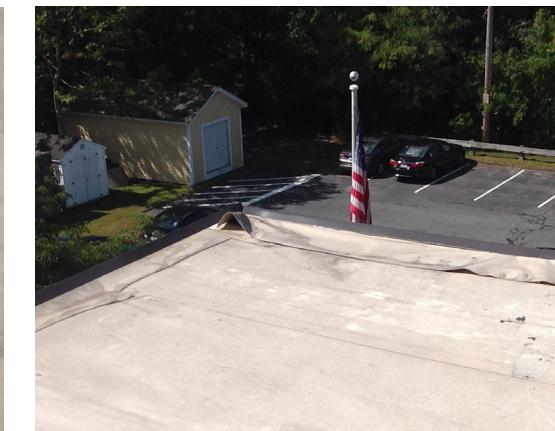
Evidence of water ponding, signs of aged flashings can be seen where membranes separate, or "pull back". (Classroom Wing - Roof 5)

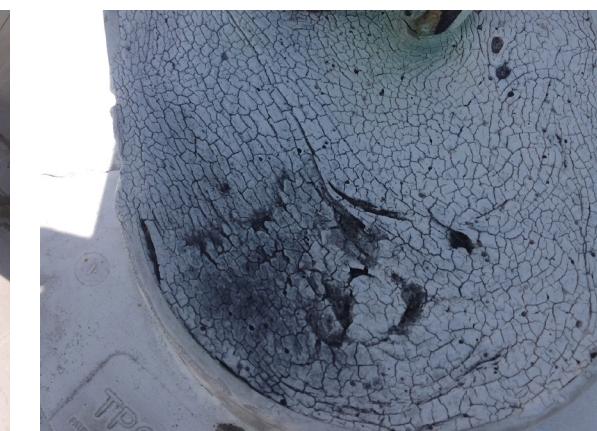
Evidence of cracked roofing membrane, due to moisture damage / ponding of water. (Office Wing - Roof 8)
