Benthic mat pilot project for Forge Pond -- Littleton sites					
	Site address	93 Matawanakee Trail	59 Matawanakee Trail	1 Chipmunk Lane	49 Matawanakee Trail
	Participants	Phil Souza and Susan Paul-Souza	Steve and Becky Hadden	Michael and Suzie Livingston	Dave and Patty Barr
Installation					
	Date of installation	6/8/2022	6/14/2022	7/9/2022	7/18/2022
	Benthic mat material	Burlap (plan to leave in place) and relocate at 6-8 weeks	Burlap (plan to leave in place)	Burlap (plan to leave in place)	Single polyethylene tarp
	Benthic mat size	592 sq ft	592 sq ft	592 sq ft	320 sq ft (40 ft x 8 ft)
	Benthic mat length (parallel to shore)	37 ft	37 ft	37 ft	8 ft
	Benthic mat length (perpendicular to shore)	16 ft	16 ft	16 ft	40 ft
	Sketch provided?	Yes	Yes	Yes. As pictured in the sketch, the mat is on the west side of the dock, our boat is always moored to the east side of the dock.	Yes
	Anchor mechanism	25 burlap bags ("sandbags") filled with 17 pounds of ½-inch washed pea gravel, placed around the edges and over the mat area about every 6 or 7 feet.	25 burlap bags ("sandbags") filled with 17 pounds of ½-inch washed pea gravel, placed around the edges and over the mat area about every 6 or 7 f

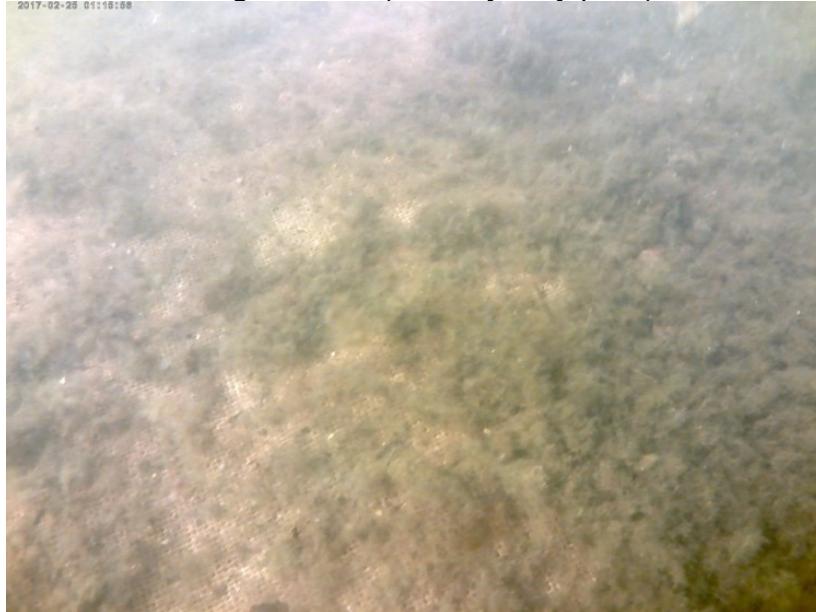
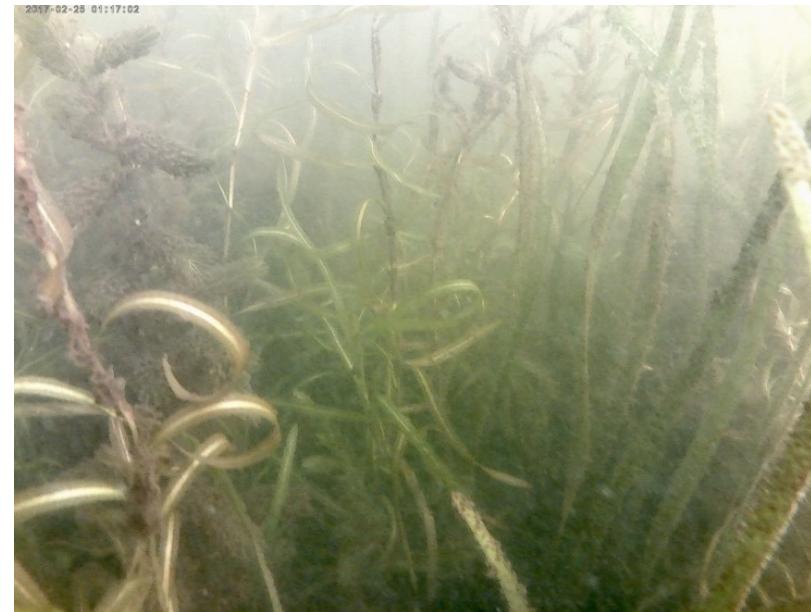
Photos 2 Months After Installation
Taken on 18 August 2022 (visibility very poor)

Weave of mat barely visible under silt.

Plants around mat grow thickly.

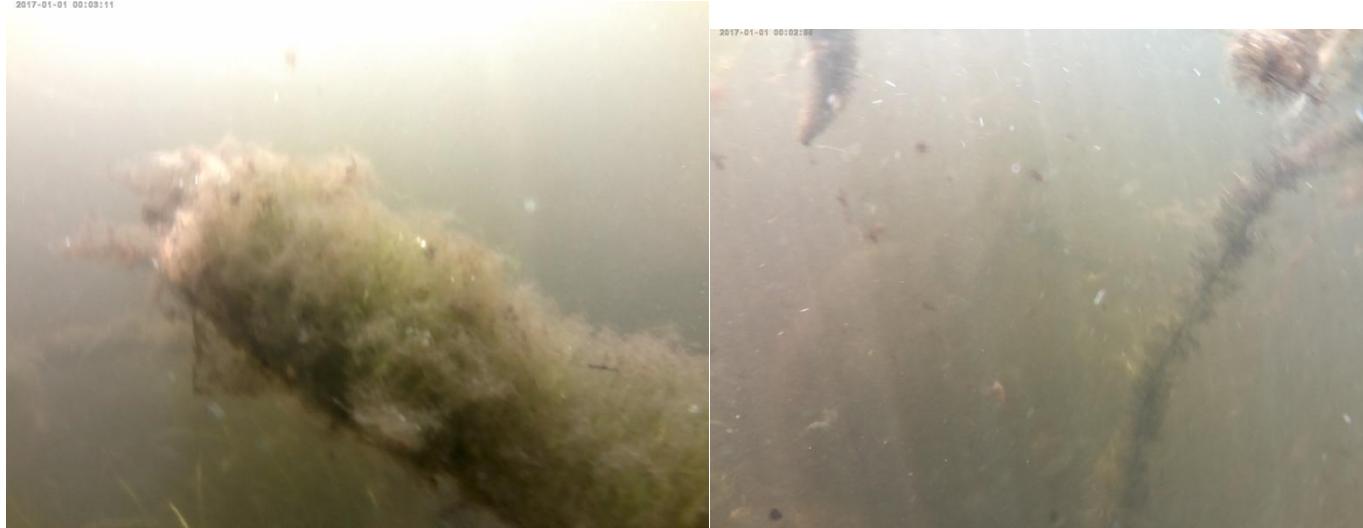
Photos Before Mat Installation

Conditions just before installation are obviously poor, but the growth of weeds is evident.

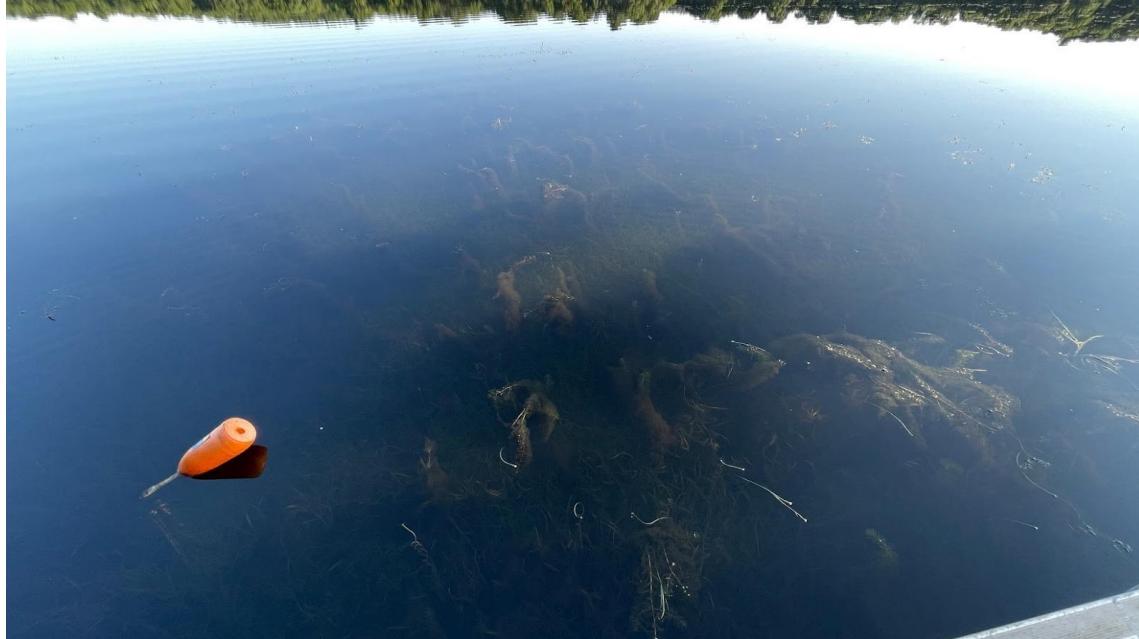
Photos in late August, approx. 6 Weeks After Mat Installation

Considerable weed growth this season due to lower water levels.

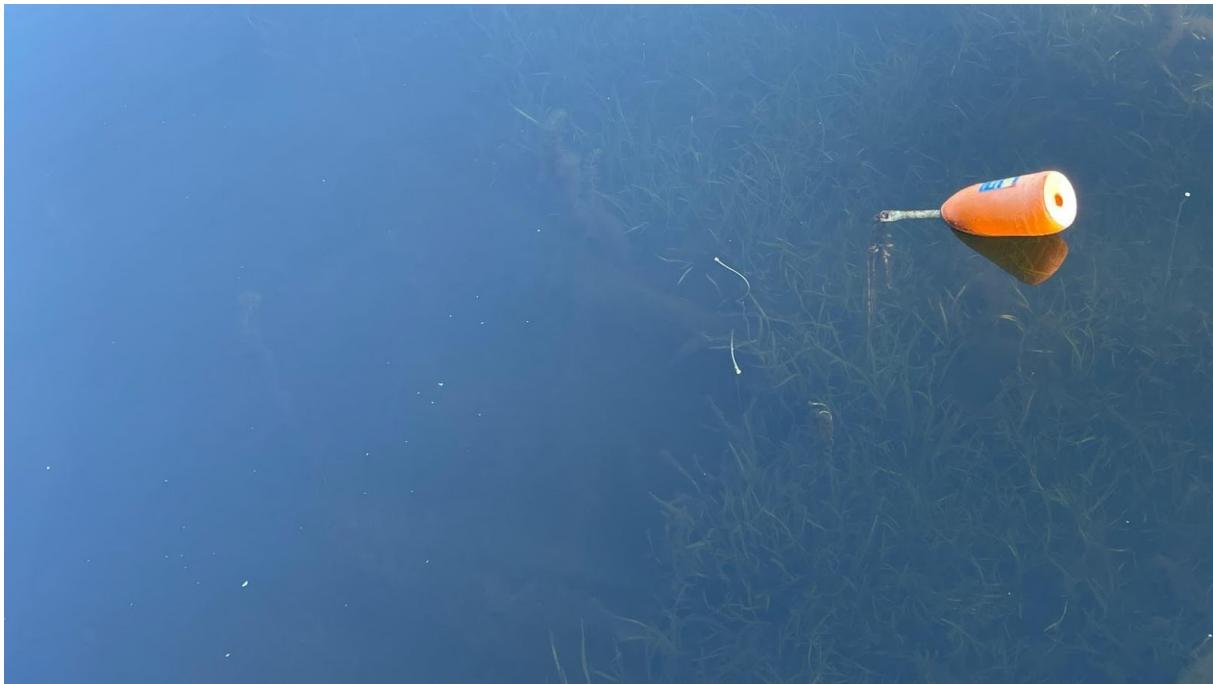
Here the corner of the mat is clearly delineated by the growth of the plants.

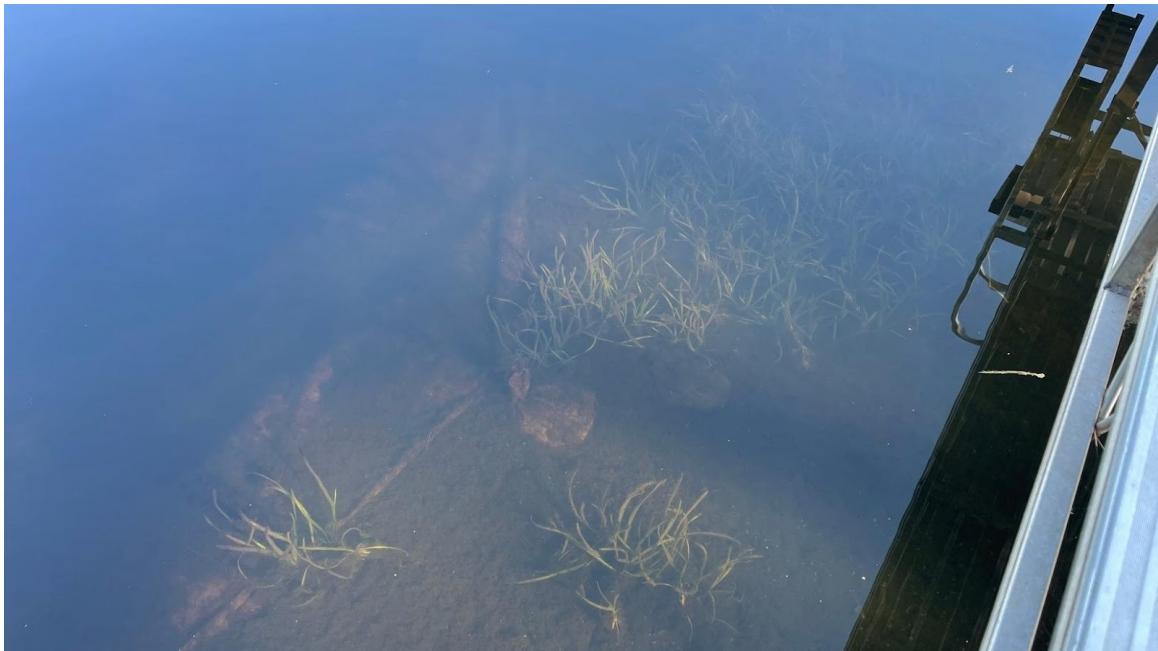
Another view where plant growth is plainly suppressed by the benthic mat.

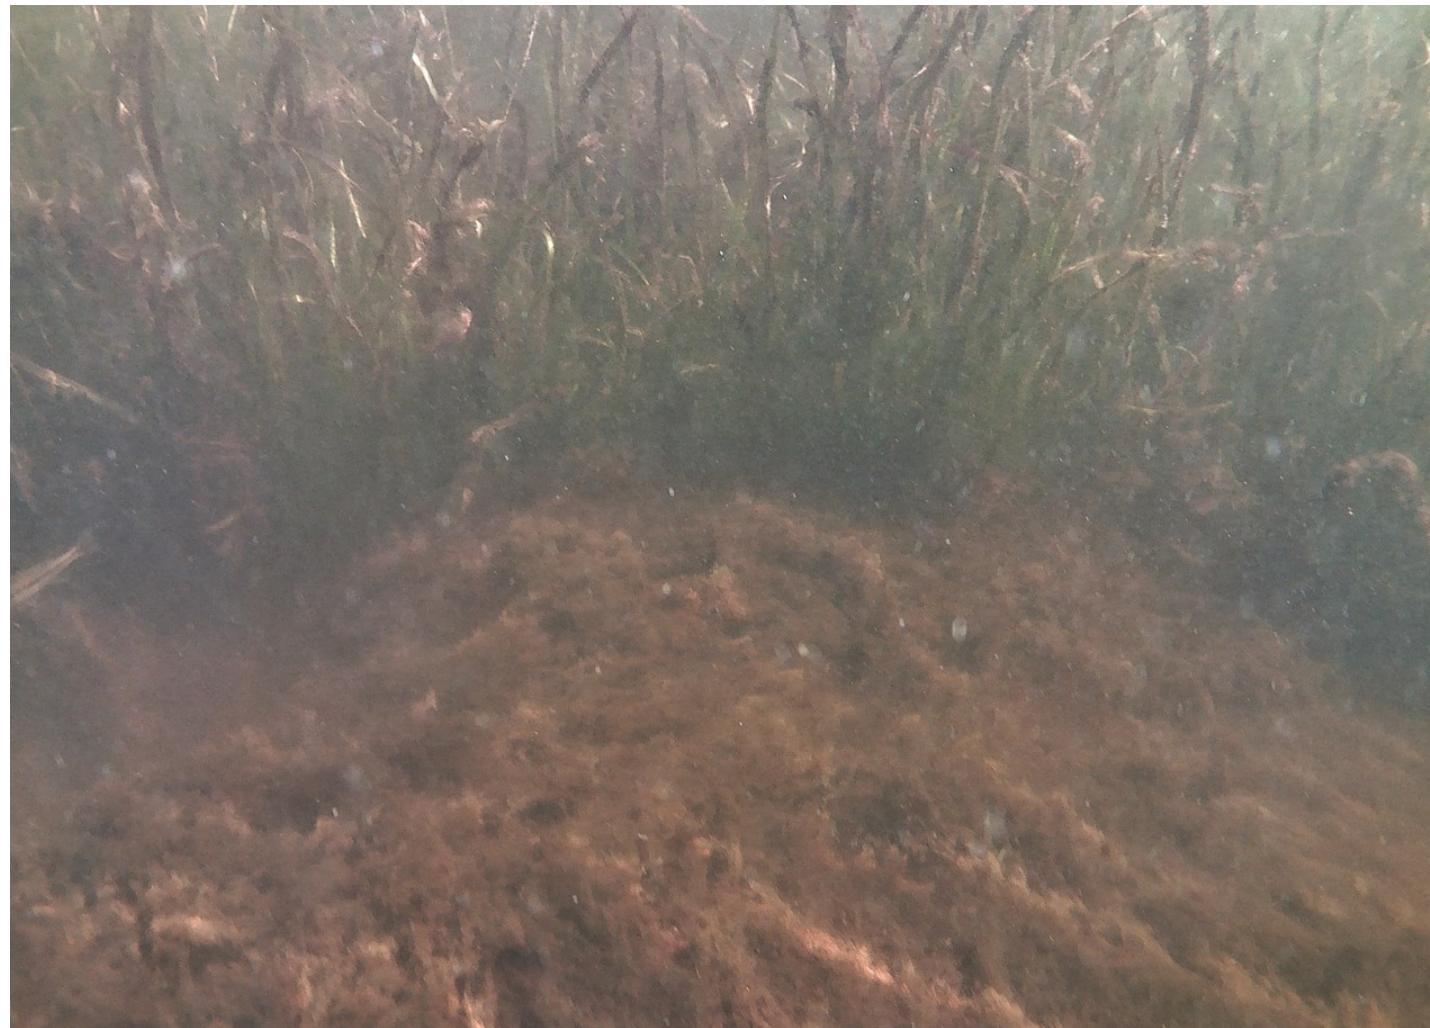
Picture just before removing mat.

Foreground shows benthic mat.

Background shows plant growth next to benthic mat.
